CAFO FACILITY INSPECTION REPORT

GH Dairy No. 3
FACILITY NAME

03/07/2013
ACTUAL INSPECTION DATE

REPORT PREPARED BY: Anthony D'Angelo (PG Environmental, LLC) ON 03/26/2013

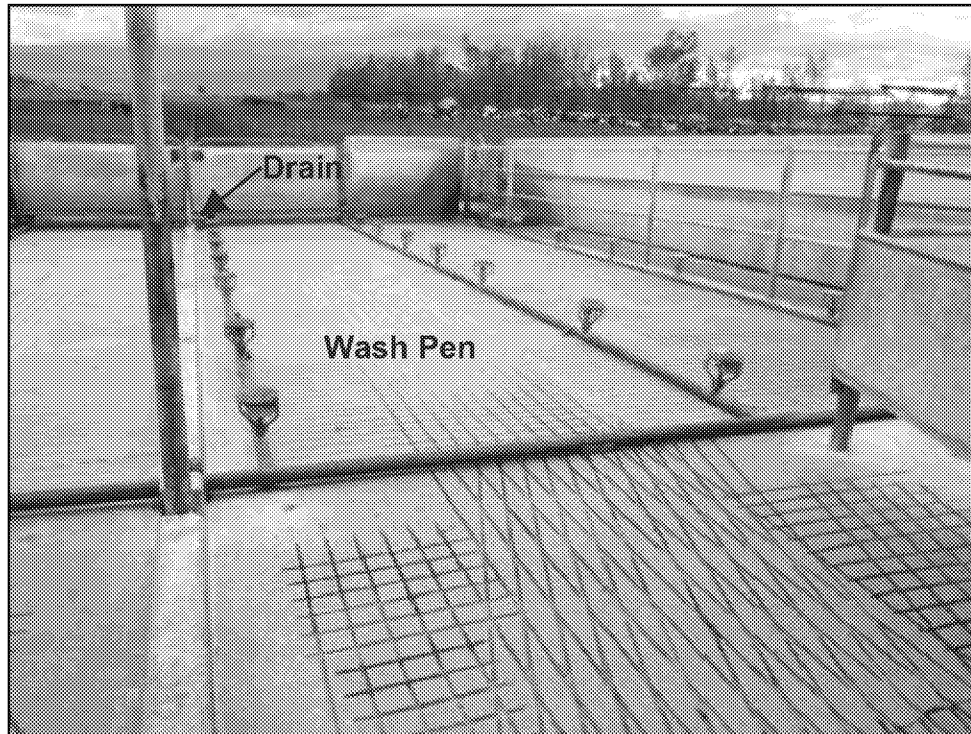
Photograph 2. View facing south of the wash pen. Note all process wastewater from the wash pen is piped to disposal valve heads along the north side of the pasture, located in the southern portion of the Facility, shown in Photographs 7 and 8.

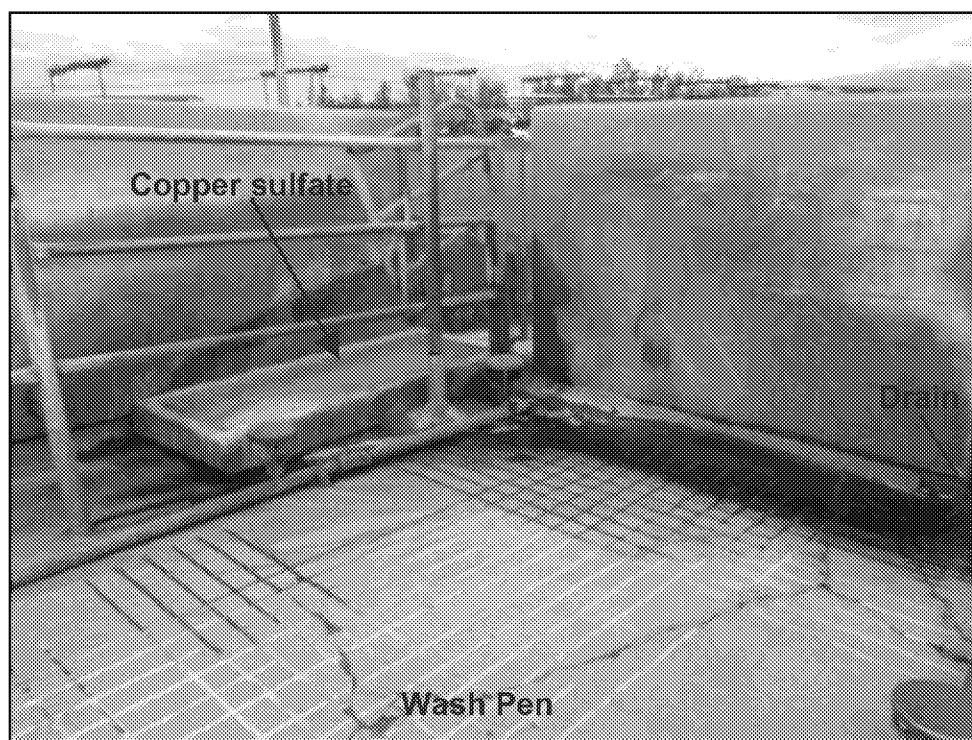
Photograph 3. View facing southeast of a copper sulfate bath located in the wash pen.

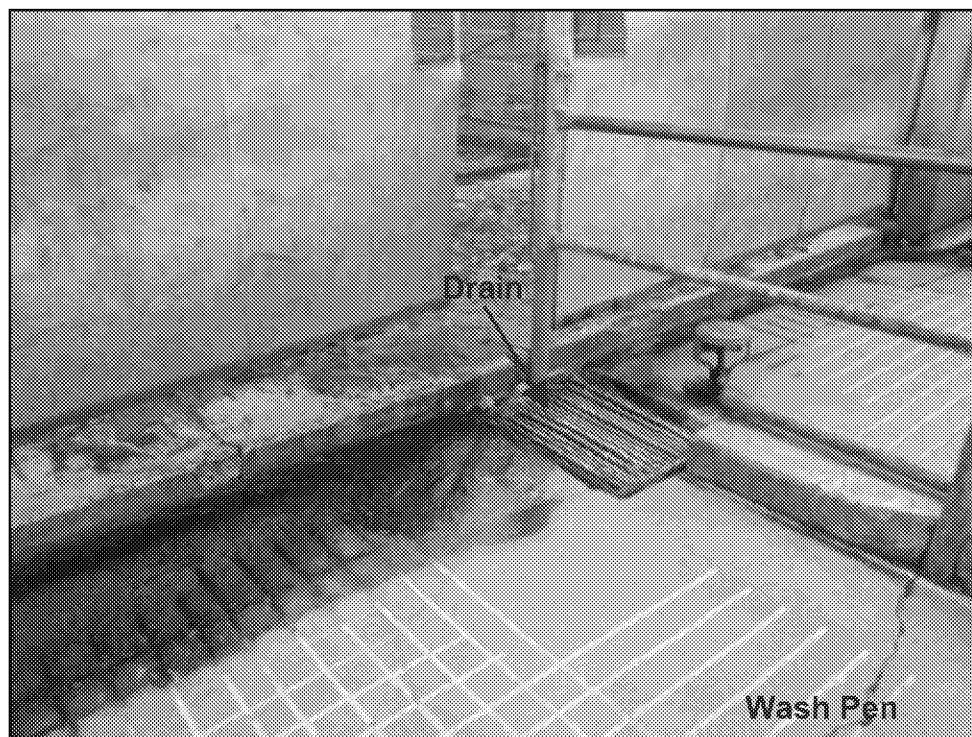
Photograph 4. Close-up view of the drain on the south side of the wash pen, shown in Photograph 3. Note this drain leads to a standpipe and disposal valve heads located on the north side of the pasture, in the southern portion of the Facility, shown in Photographs 7 and 8.

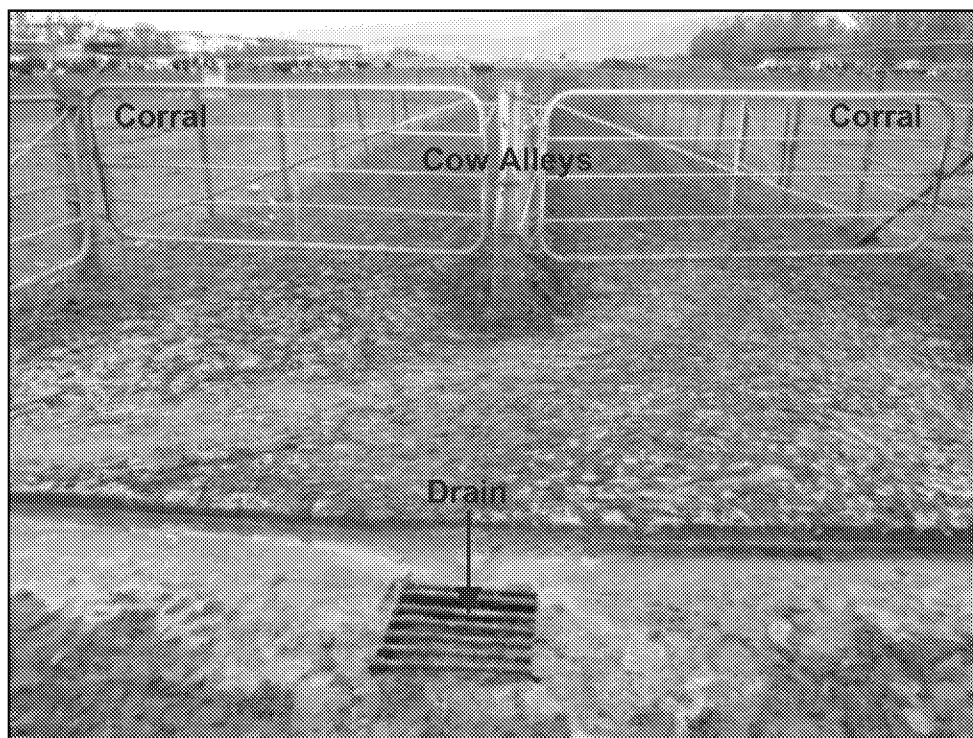
Photograph 5. View facing south of a drain immediately south of the wash pen, on the north side of the cow alleys.

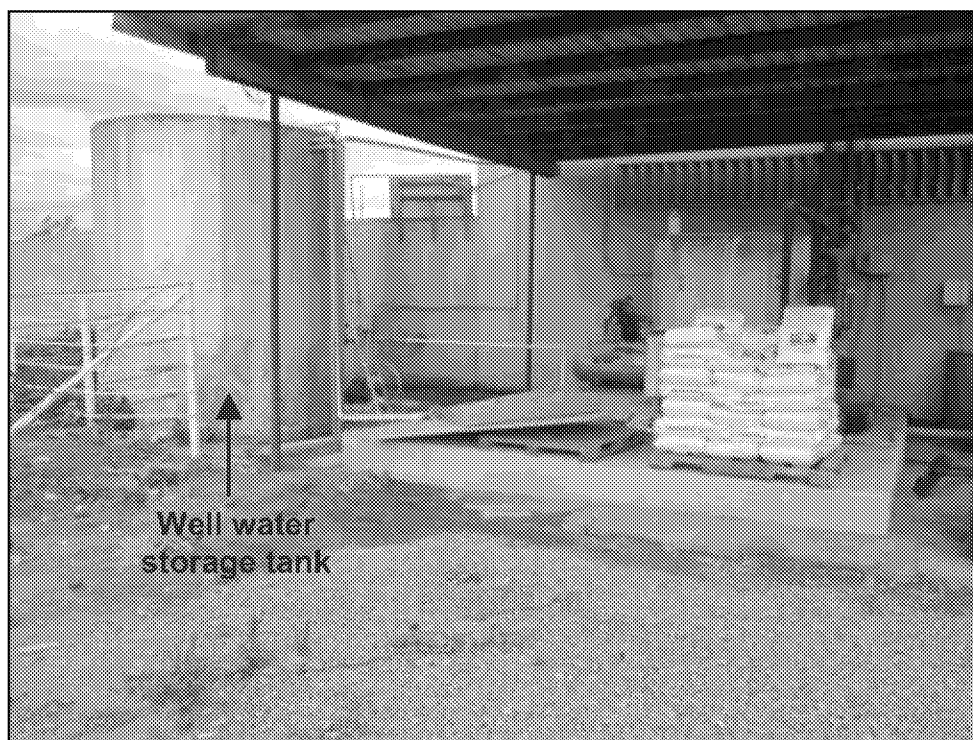
Photograph 6. View facing southwest of a well water storage tank located on the east side of the milking barn. Note the well water is combined with process wastewater and used to flush the cow alleys and process wastewater lines.

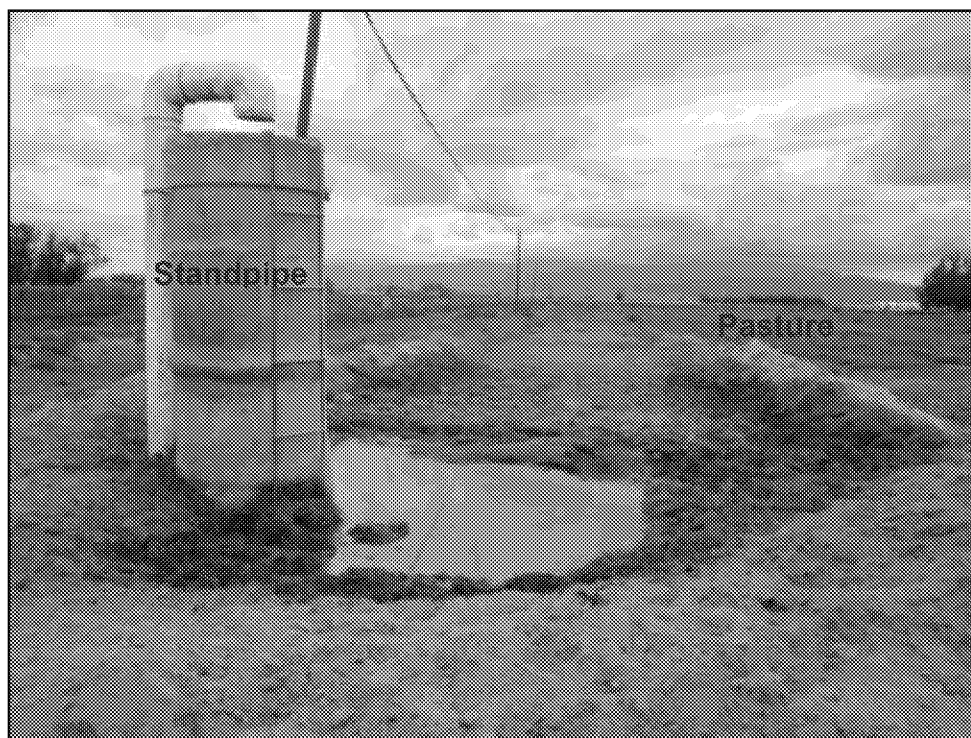
Photograph 7. View facing south of the standpipe located in the northeast corner of the pasture. Note the standpipe conveys process wastewater from the milking barn to fifteen (15) disposal valve heads on the north side of the pasture, located in the southern portion of the Facility.

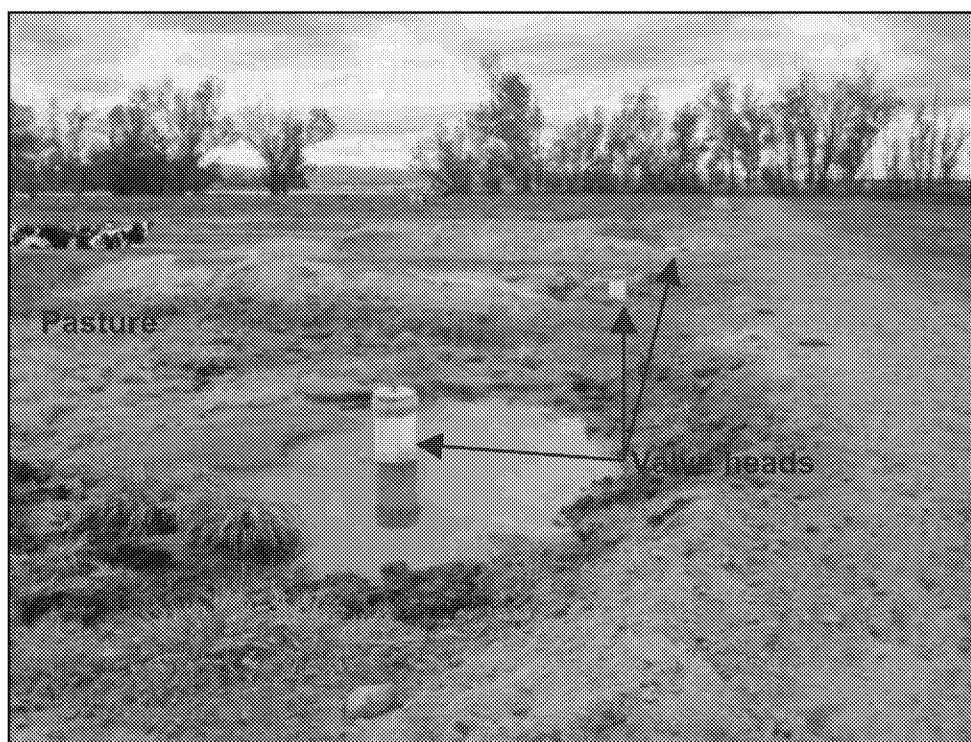
Photograph 8. View facing west of the disposal valve heads located on the north side of the pasture.

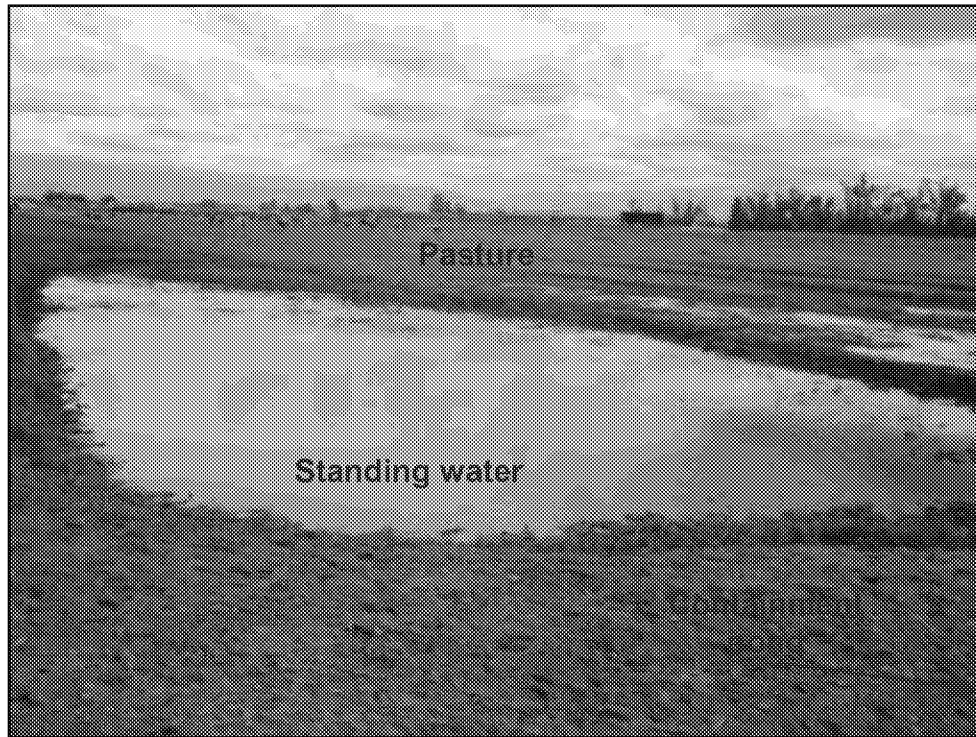
Photograph 9. View facing northeast of standing water located in the southwest corner of the pasture, adjacent to the containment pond.

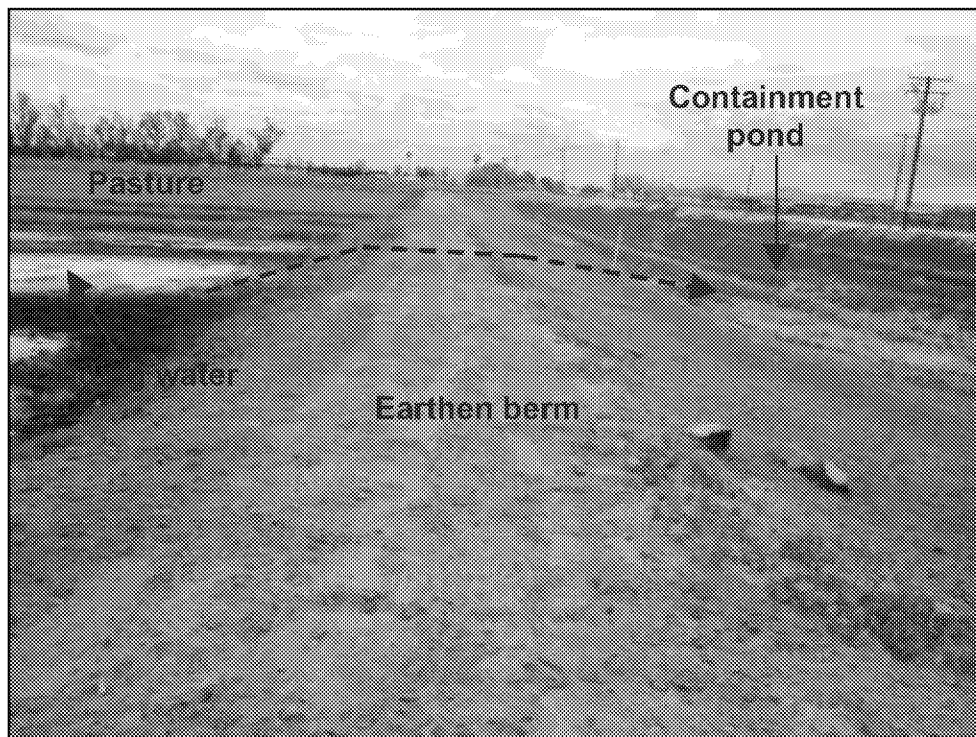
Photograph 10. View facing east of standing water located in the southwest corner of the pasture, adjacent to the containment pond, shown in Photograph 9. Note excess process wastewater that accumulates in the pasture flows south over the earthen berm and into the containment pond.

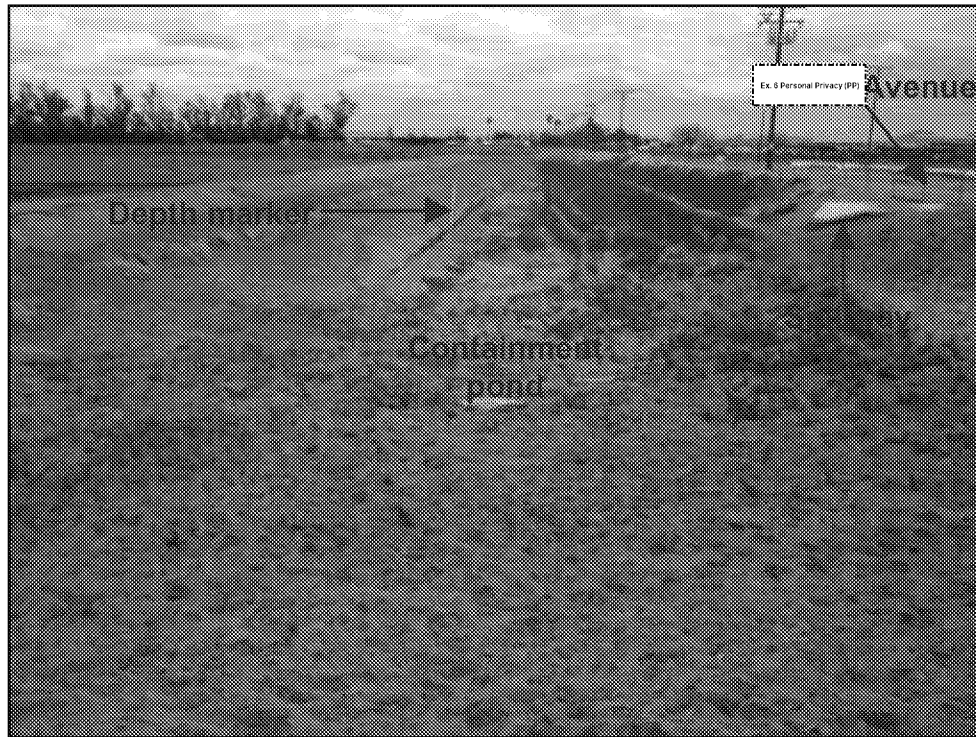
1. Weekly Storm Water Management Structure visual inspection documentation was not retained onsite or available for review at the time of the inspection as required by the Permit. Specifically, Mr. Silva stated that the water level in the containment pond (refer to Photos 11 and 16) located along the southern perimeter of the Facility is evaluated and recorded weekly; however, documentation of pond inspections are maintained offsite at the Hettinga main office at Ex. 6 Personal Privacy (PP) in Ontario, CA. Permit Attachment B - Monitoring and Reporting Program, Section I.A states "all monitoring data shall be maintained for at least five years and shall be made available to Regional Board, SWRCB, USEPA staff and/or their authorized representatives (including an authorized contractor acting as their representative), upon request." In addition, Permit Attachment B - Monitoring and Reporting Program, Section I.B states "all containment structures, including but not limited to, ponds, berms, and wastewater distribution lines, shall be inspected at least once a week during the entire year and at least once each 24-hour period during a storm event in which rainfall exceeds 0.5 inches in 24 hours. The findings of these inspections shall be documented on the attached CAFO Weekly Storm Water Management Structure Inspections Log Sheet (Attachment 1[of the Permit])." As a result, the inspector, was unable to verify if inspections and documentation were conducted in accordance with the Permit. Permit Attachment B - Monitoring and Reporting Program, Section I.A states "all monitoring data shall be maintained for at least five (5) years and shall be made available to Regional Board, SWRCB, USEPA staff and/or their authorized representatives (including authorized contractor acting as their representative), upon request."

Photograph 11. View facing east of the containment pond and spillway located along the southern perimeter, adjacent to Ex. 6 Personal Privacy (PP) Avenue.

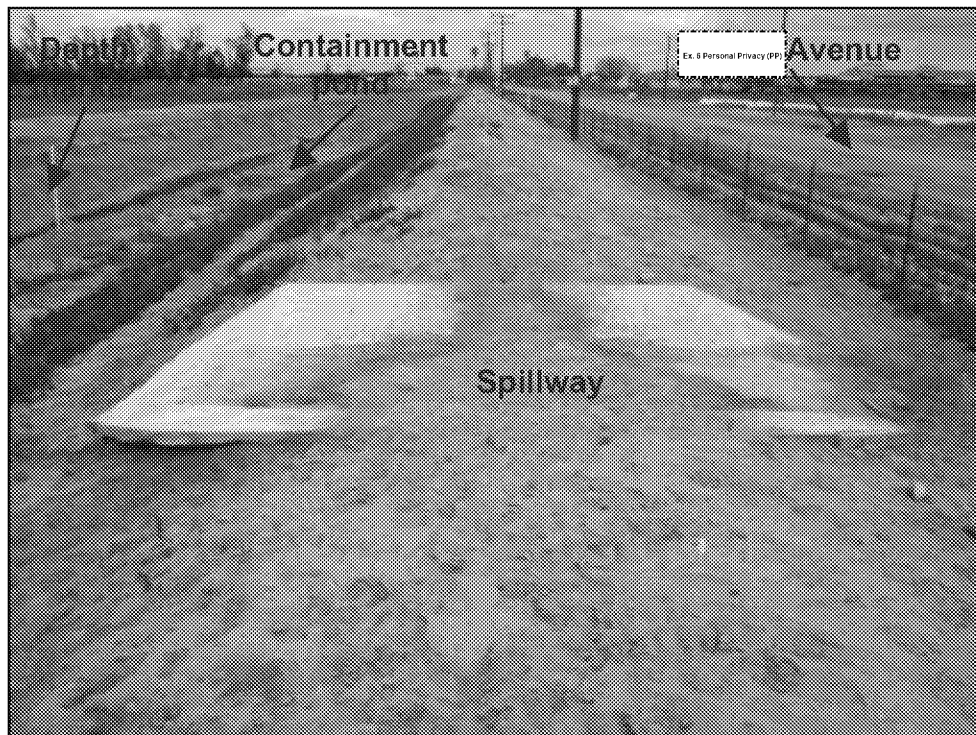
Photograph 12. View facing east of the concrete spillway located on the southern embankment of the containment pond, adjacent to Ex. 6 Personal Privacy (PP) Avenue.

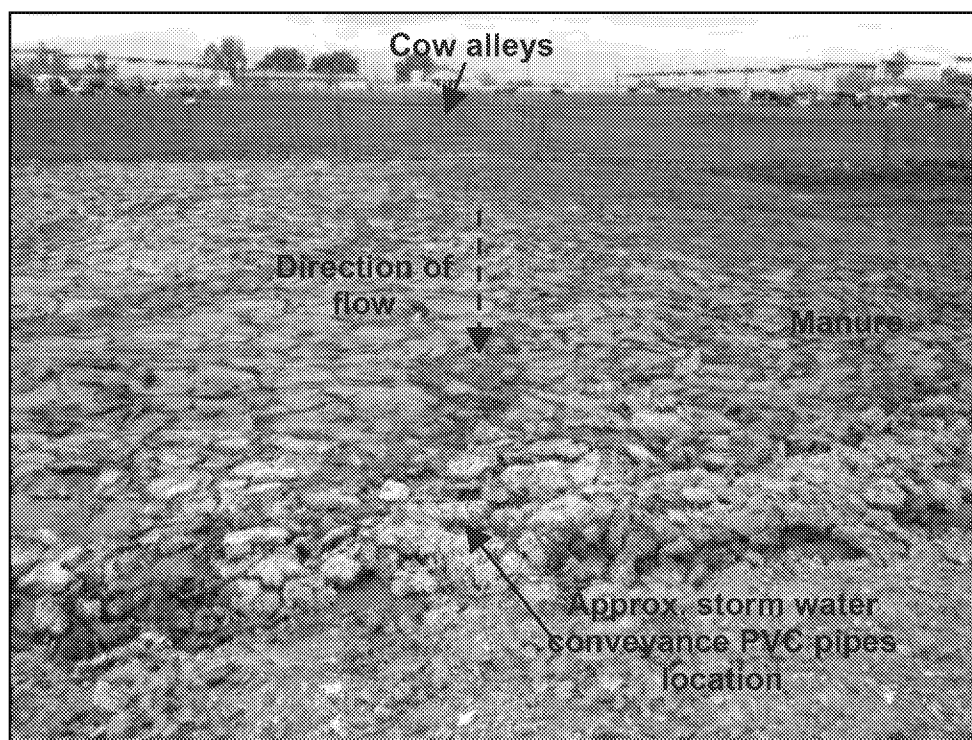
Photograph 13. View facing north of the storm water flow pathway from the corrals south into the dirt field.

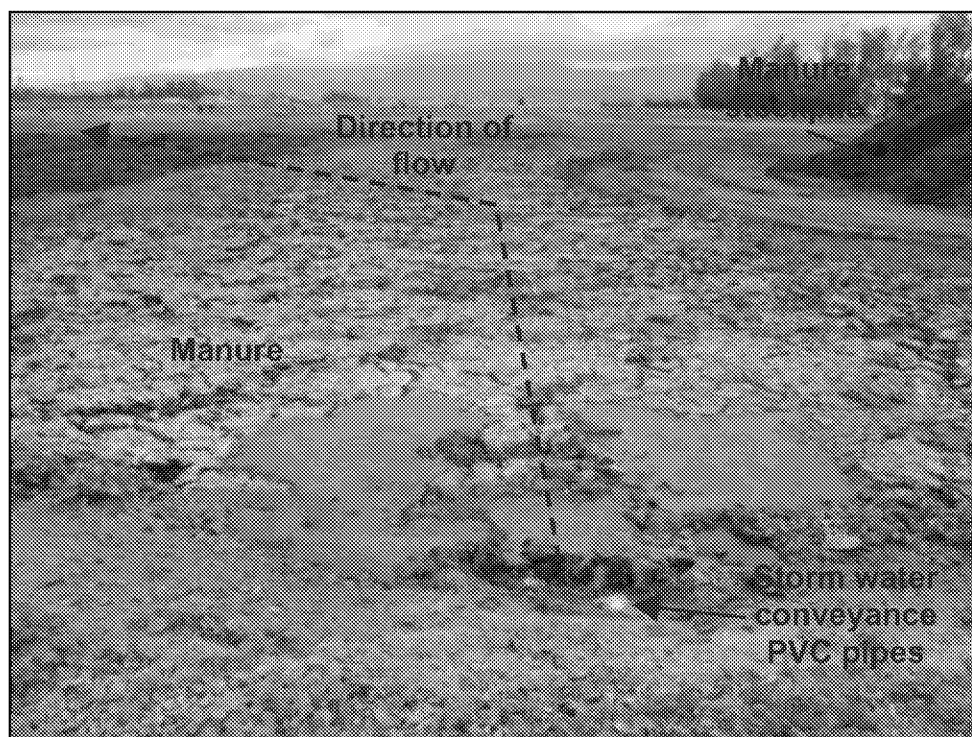
Photograph 14. View facing south of the storm water conveyance PVC pipes outlet into the dirt field.

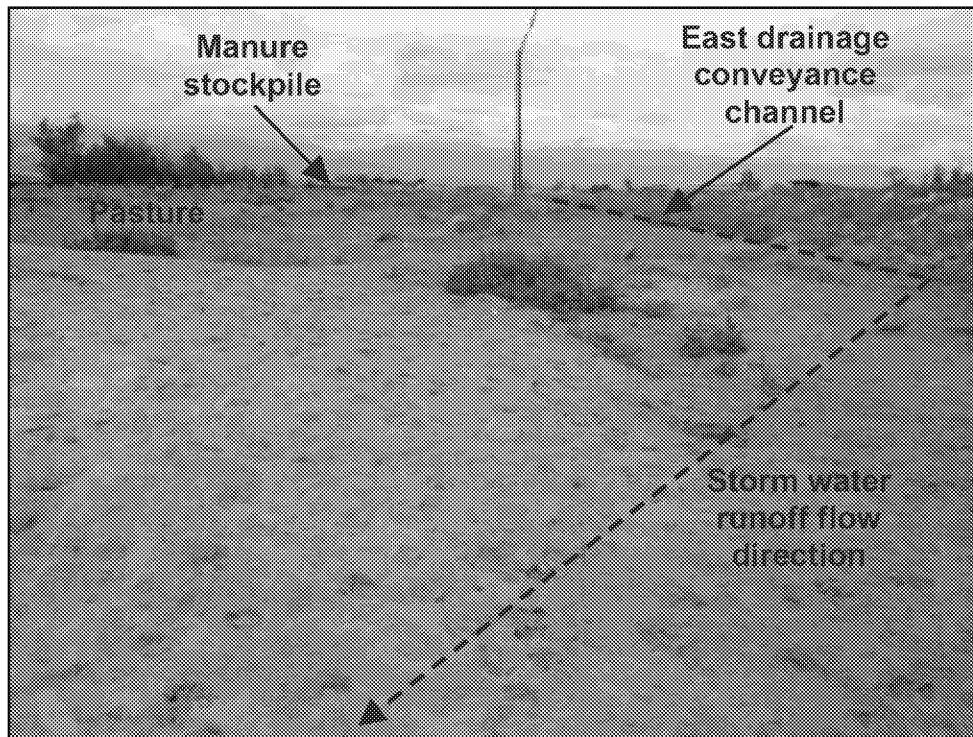
Photograph 15. View facing north of the east drainage conveyance channel that conveys storm water runoff from the corrals to the containment pond located along the southern perimeter of the Facility.

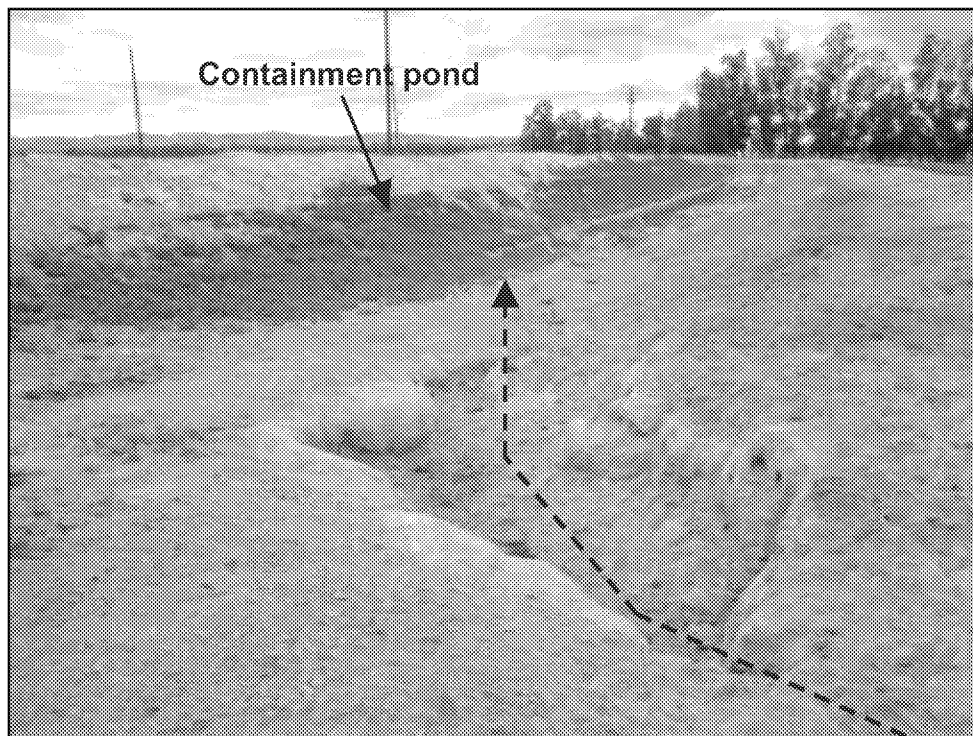
Photograph 16. View facing southwest of the storm water runoff conveyance channel entrance point into the east side of the containment pond from the east drainage conveyance channel, shown in Photograph 15.

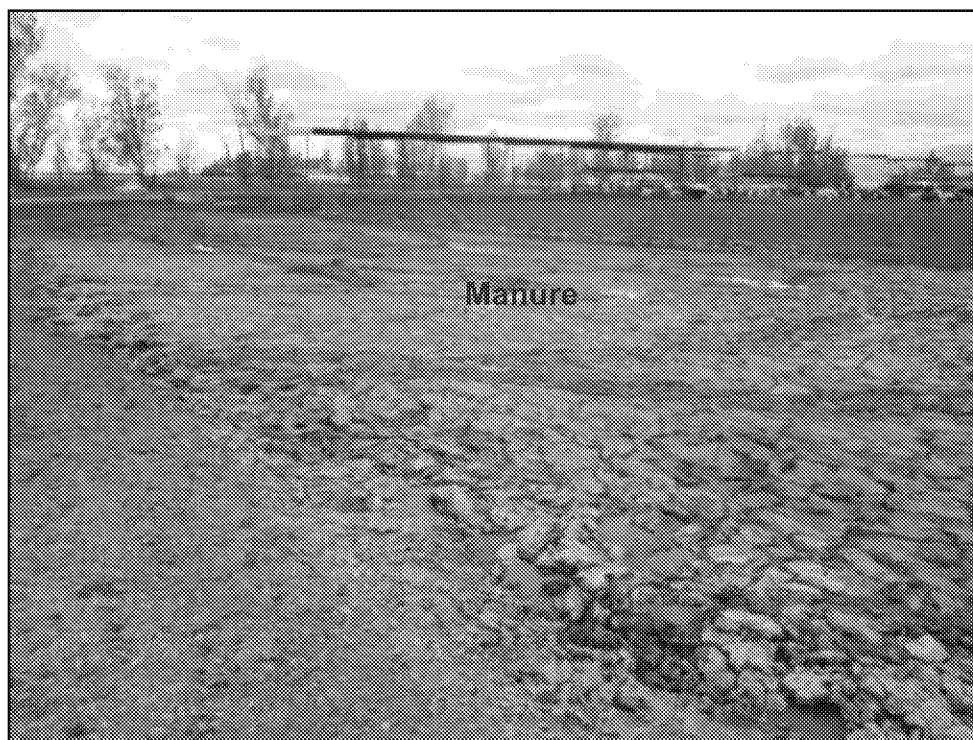
Typical Depth of Manure in Corrals (in inches): **3-8**
Estimated Freeboard in Fullest Lagoon (in feet): **8**
Date of Last Lagoon Solids Removal, per Facility Representative: **Approx. mid-2010**
Disposal Location for Lagoon Solids: **Onsite manure stockpile located in the central portion of the Facility (refer to Photos 17 and 18)**

Photograph 17. View facing northwest of manure south of the corrals, in the dirt field.

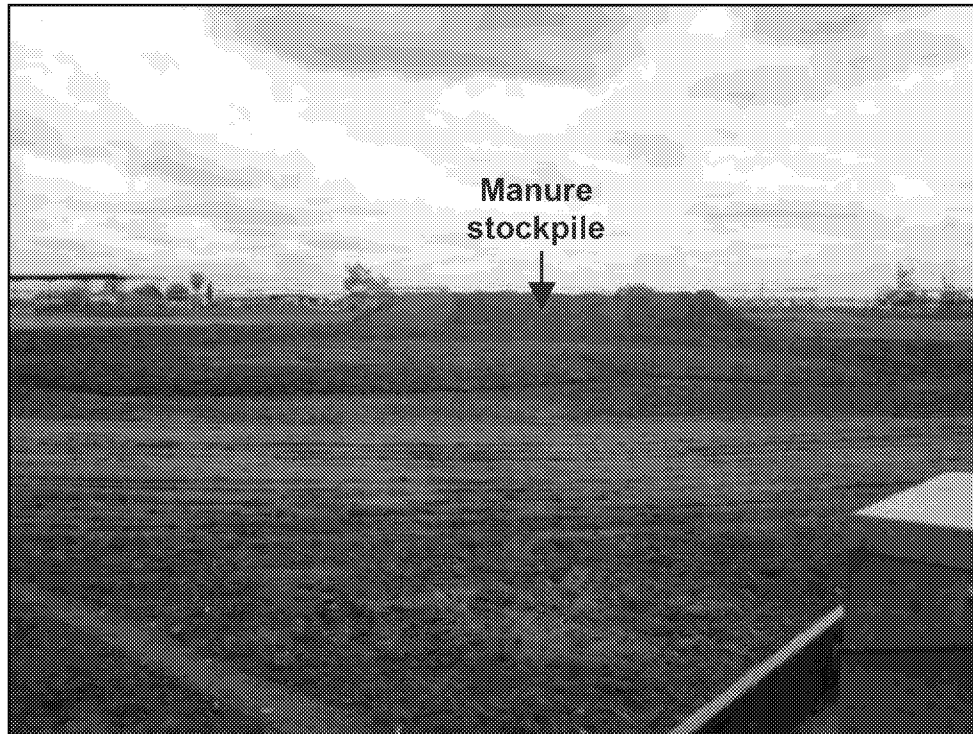
Photograph 18. View facing east of the manure stockpile located in the dirt field, immediately south of the corrals, and north of the pasture.
